HUNTINGTON BUILDING

168 S.E. 1 STREET

Designation Report

REPORT OF THE CITY OF MIAMI PLANNING DEPARTMENT
TO THE HERITAGE CONSERVATION BOARD
ON THE POTENTIAL DESIGNATION OF THE
THE HUNTINGTON BUILDING
168 S.E. 1 STREET
AS A HERITAGE CONSERVATION ZONING DISTRICT

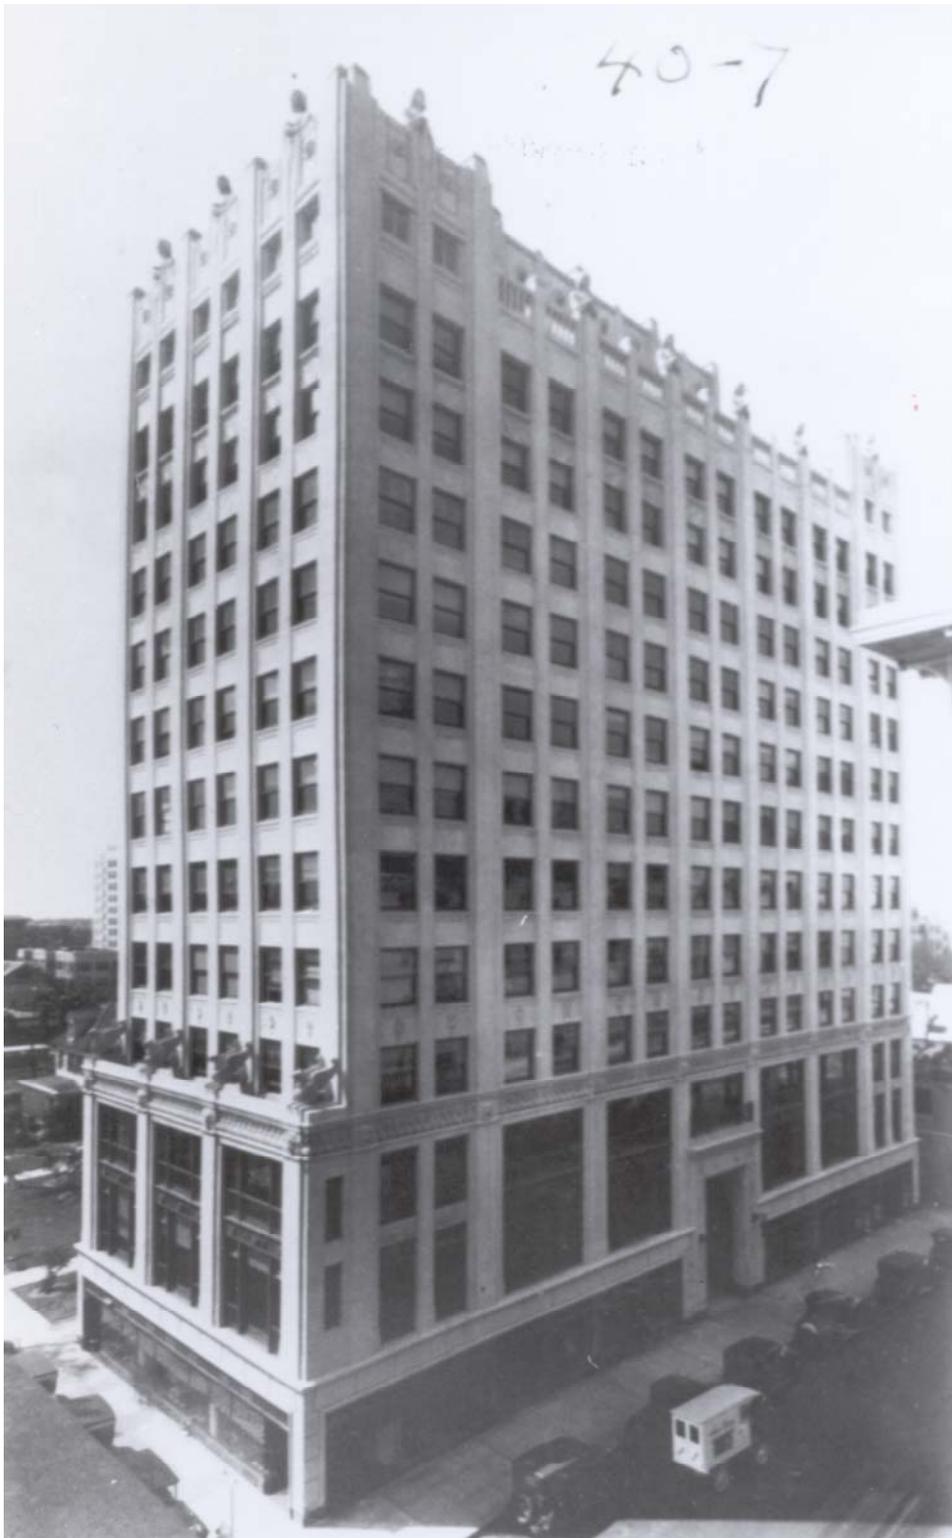
Huntington Building
168 S.E. 1 Street
East and North (front) facades
c. 1930
(Courtesy Miami-Dade Public Library)

The Huntington Building is a thirteen story commercial building of steel frame construction. Rectangular in plan, the building is covered with smooth stucco and is topped by a flat roof. The building features fourteen bays across the north (front) façade and six bays across its side facades.

The most outstanding feature of the building is its parapet, which features a row of eleven knight-like figures. Masonry piers, joined by masonry balustrades with square balusters, also embellish the parapet. The roof is stepped up to create the thirteenth story on the two outer bays.

The verticality of the building is reinforced by a series of large and small vertical piers separating each bay. The corner set backs of the piers are now emphasized by contrasting paint colors.

The building is highlighted between the third and fourth stories by a masonry string course and is stepped back above the third story on the east façade. Originally, four winged griffins rested on this setback, and ornamental detailing embellished the string course.
