SECURITY BUILDING

117 NE 1ST AVENUE

Designation Report

REPORT OF THE CITY OF MIAMI
PRESERVATION OFFICER
TO THE HISTORIC AND ENVIRONMENTAL PRESERVATION BOARD
ON THE POTENTIAL DESIGNATION OF THE
SECURITY BUILDING
AS A HISTORIC SITE

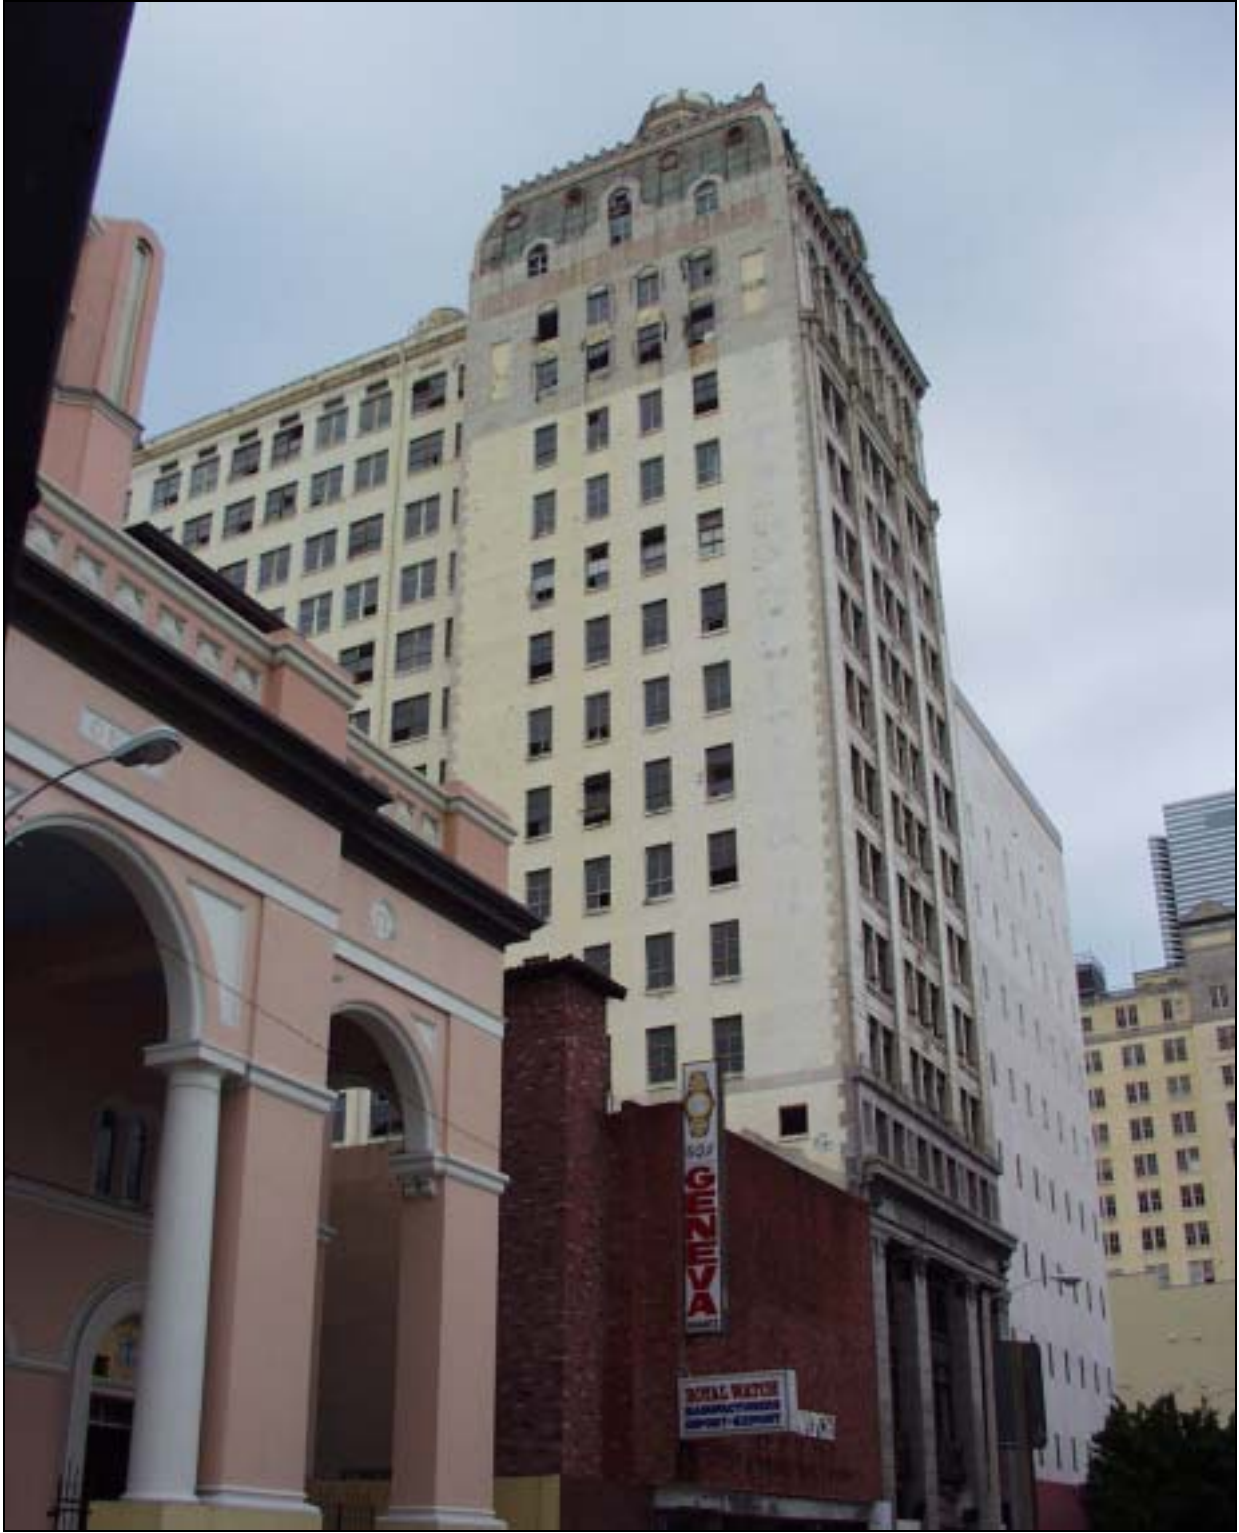
Security Building
117 NE 1st Avenue
North and west (front) façades
2002

West Elevation:

With only a 50-foot frontage, the architect made a grand statement by creating an almost temple-like base, comprised of the first three stories. Engaged pilasters, that also frame the center bay, articulate the corners creating three distinct bays. Spandrels between the floors are bronze and feature relief ornament. The pilasters carry the entablature, with the name "Security Building" in incised letters. A dentilled molding ornaments the cornice that terminates this division of the building.

The fourth floor begins the transition to the high-rise portion of the building. Stone panels with a similar relief accent the corners and separate the bays. Above the windows of the fourth floor is another projecting element, a stringcourse that is ornamented with a guilloche pattern in relief.

Floors five through thirteen continue the three bays with window arrangements that are grouped in pairs on each of the end bays, and are grouped in three in the center bay, emphasizing the importance of the center bay to the entire composition. The windows are a metal casement type.

The fourteenth and fifteenth floors function as the base for the great mansard roof, which terminates the building. To balance the composition, the two floors are treated as if they were one by the use of a round arch at the fifteenth floor that is carried by the pilasters of the fourteenth floor, so that the two floors are visually united.

The mansard roof of the Security Building is clad in copper and terminates in a series of antefixae. A series of arches containing windows and serving as dormers penetrate the roof. Bull's-eye windows are placed between the arched windows.

An eight-sided cupola that extends from the center of the roof is fenestrated on each side with a multi-paned arched window. The dome of the cupola also is clad in copper.

The north and south ends of the building are not ornamented. The windows are a metal casement type. The quoining on the corners of the west elevation is repeated in the north and south elevations of the building.

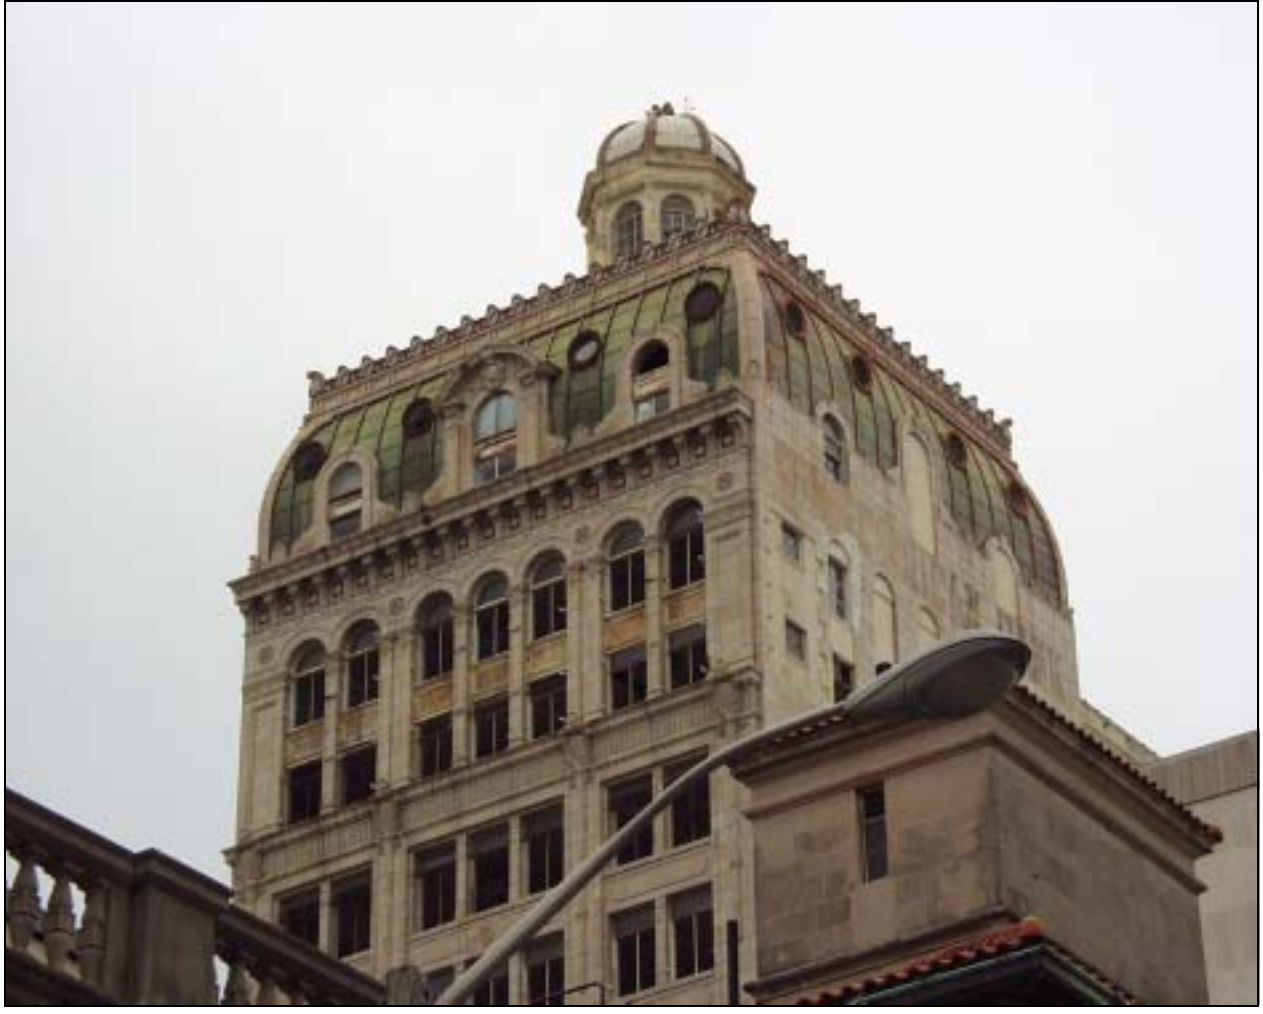
Security Building
117 NE 1st Avenue
South and west façades
2002
